Customer case study

Diagnostic test equipment

HYCO

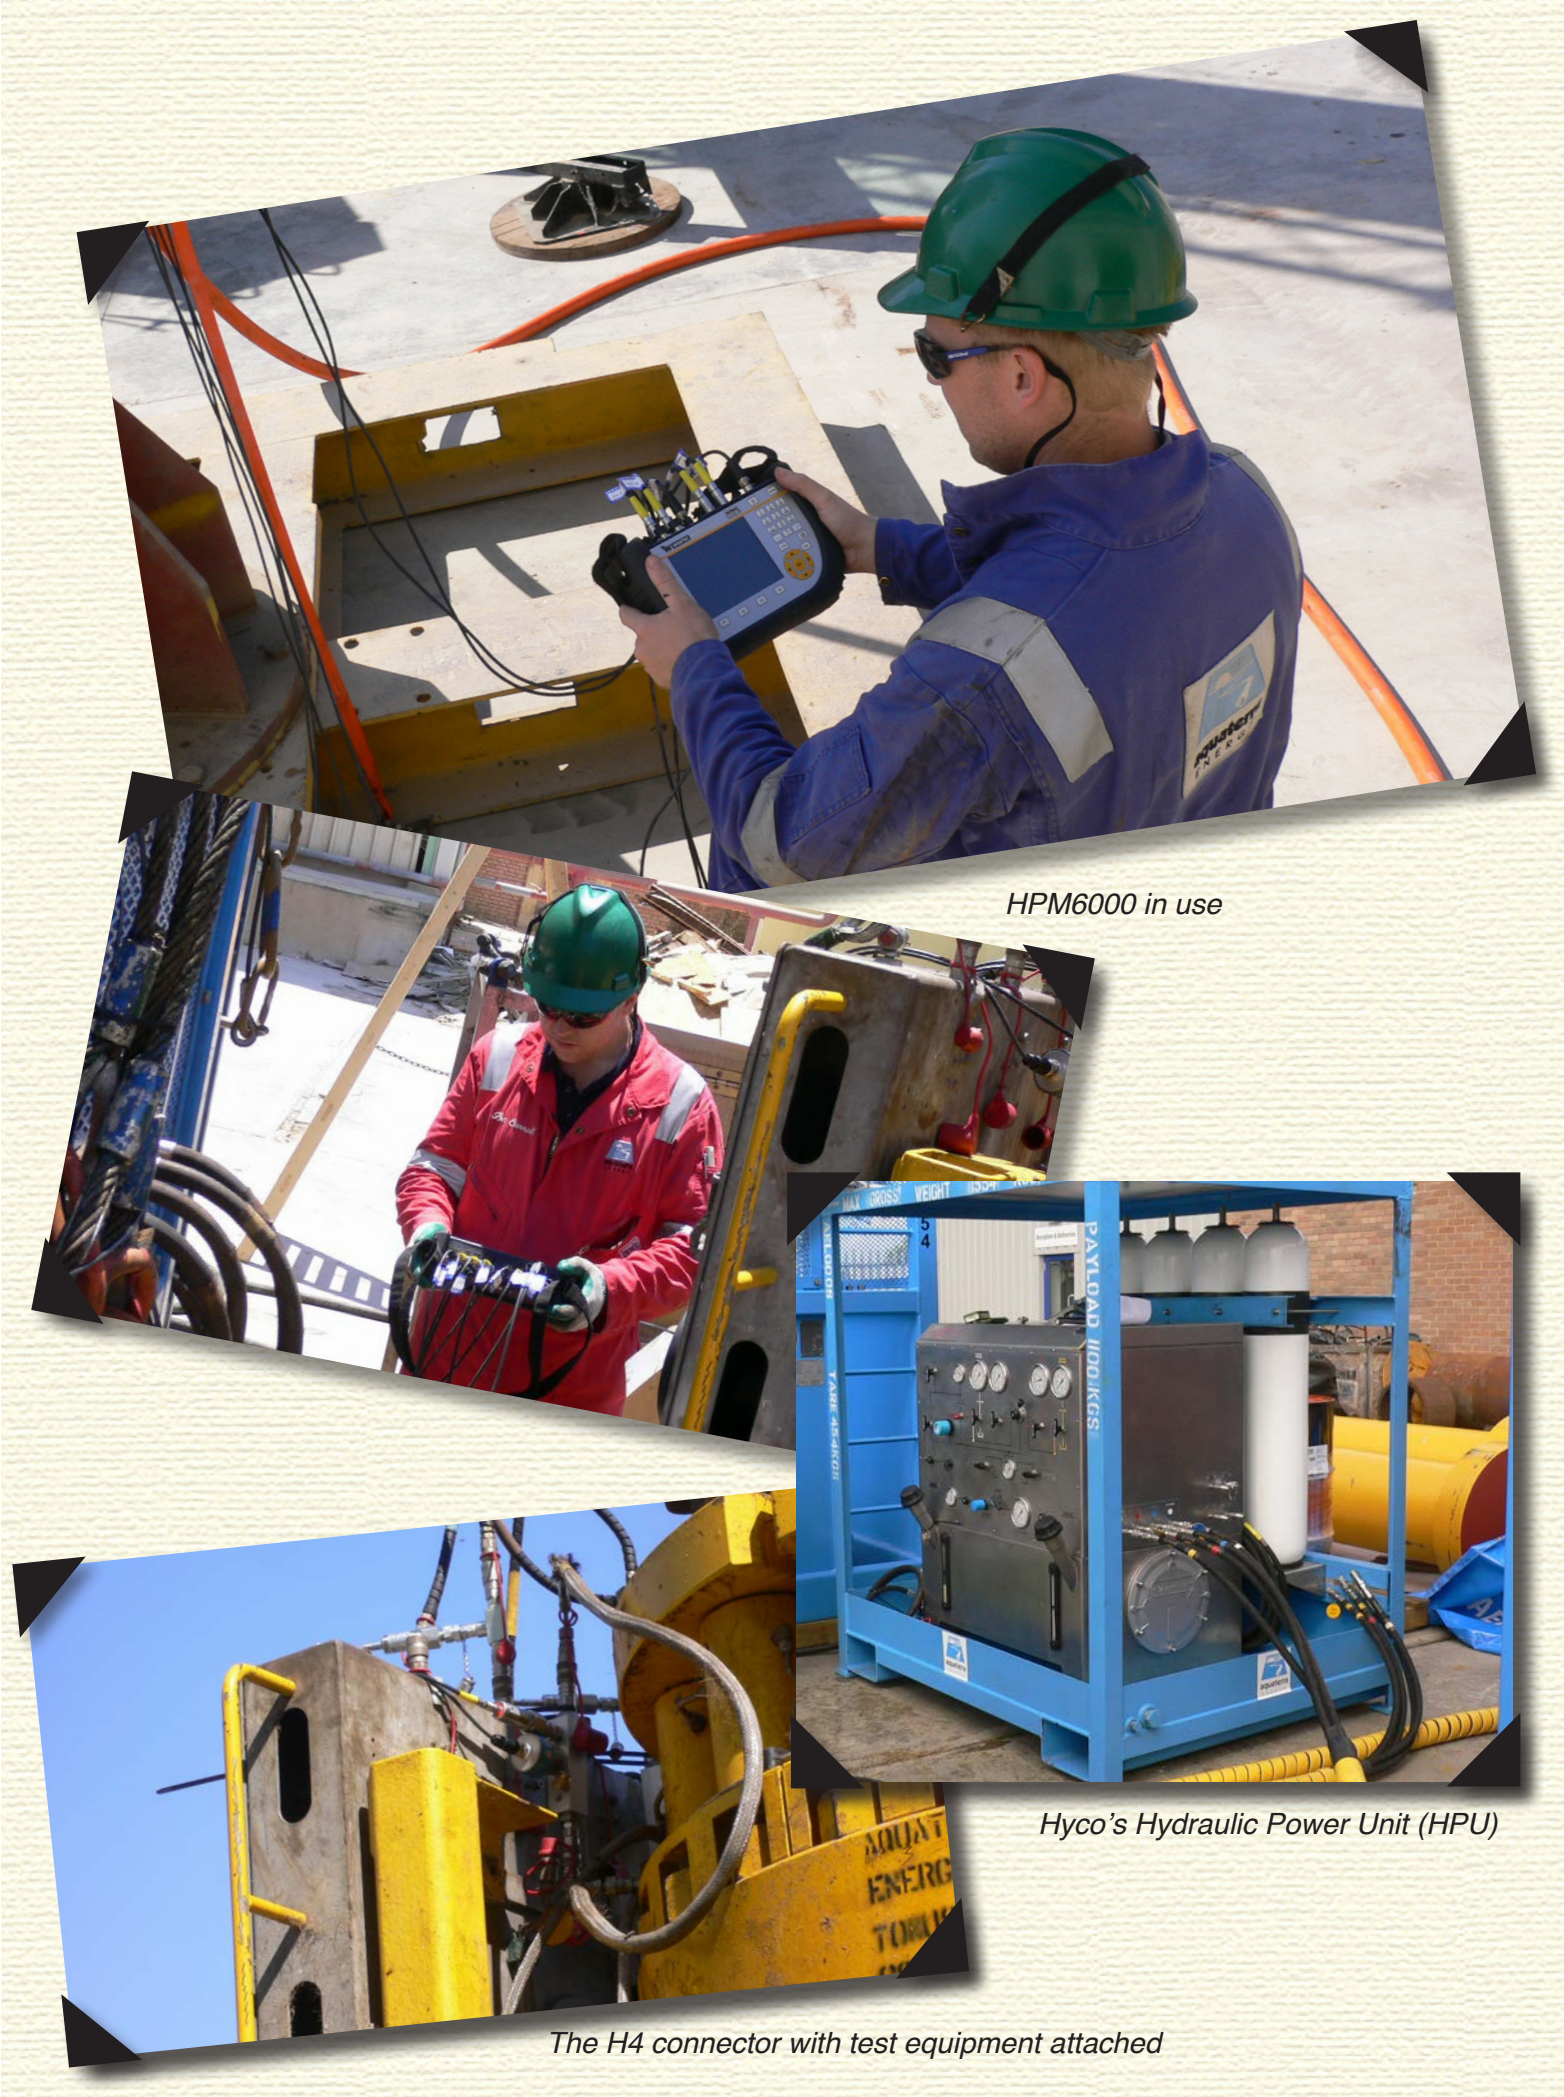
HPM6000 in use

Hyco's Hydraulic Power Unit (HPU)

The H4 connector with test equipment attached

A few weeks later, Hyco was in possession of a hire kit with sensors which had the capability of measuring two flows, six pressures and six temperatures. Despite only having had an hour or two to get to know his way around the Webtec product, software and menus, a representative from Hyco Ltd was soon back in Egypt where he was able to quickly establish that the fault did in fact lie with the connector.
